Historic Preservation Commission

Agenda

May 18, 2015

ITEM: Landmark eligibility probable cause determination for 821 LaFarge Avenue

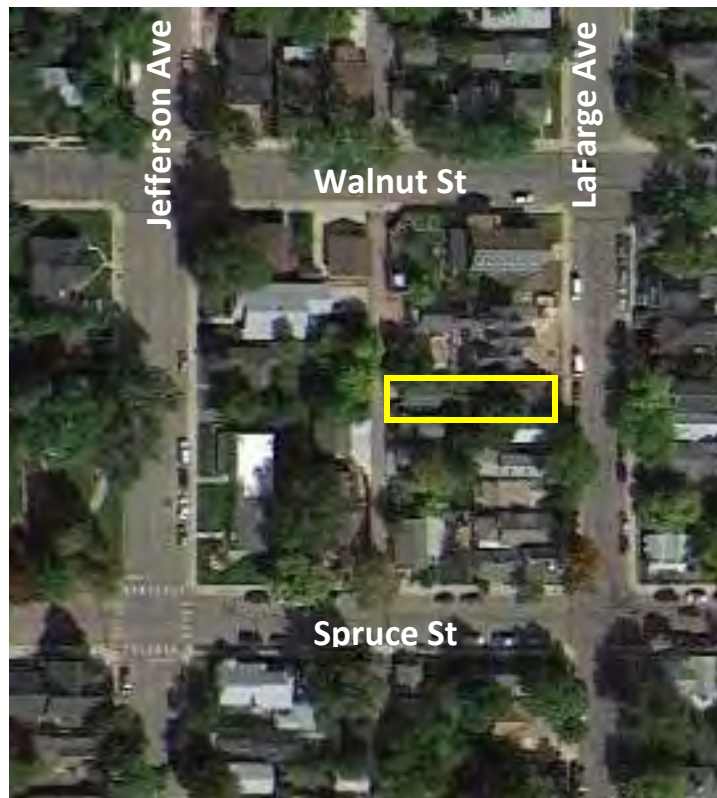
821 LaFarge Current Photo (East elevation)

The house, constructed circa 1885, is situated on a narrow lot, with small unfenced planted grass front yard to the east, and a large backyard to the west. The house is wood-frame residence, supported by a low concrete foundation, with white asbestos shingle siding exterior walls. The house is covered by a moderately-pitched side gable roof, with asphalt shingles and boxed eaves. An early saltbox addition extends the building to the west. Windows are 1/1 and 2/2 double-hung sash, with painted white wood frames and surrounds. The windows also have aluminum storm/screen sash. A porch extends the full length of the façade. Painted white turned columns, with scrolled brackets, support the porch roof.

The structure has maintained a high level of integrity. Between 1948 and the 1960s, the original wood siding was replaced with asbestos shingle siding. The chimney was removed after the 1970s photo of the house. Board and batten shutters have been added to the north side since 2013.

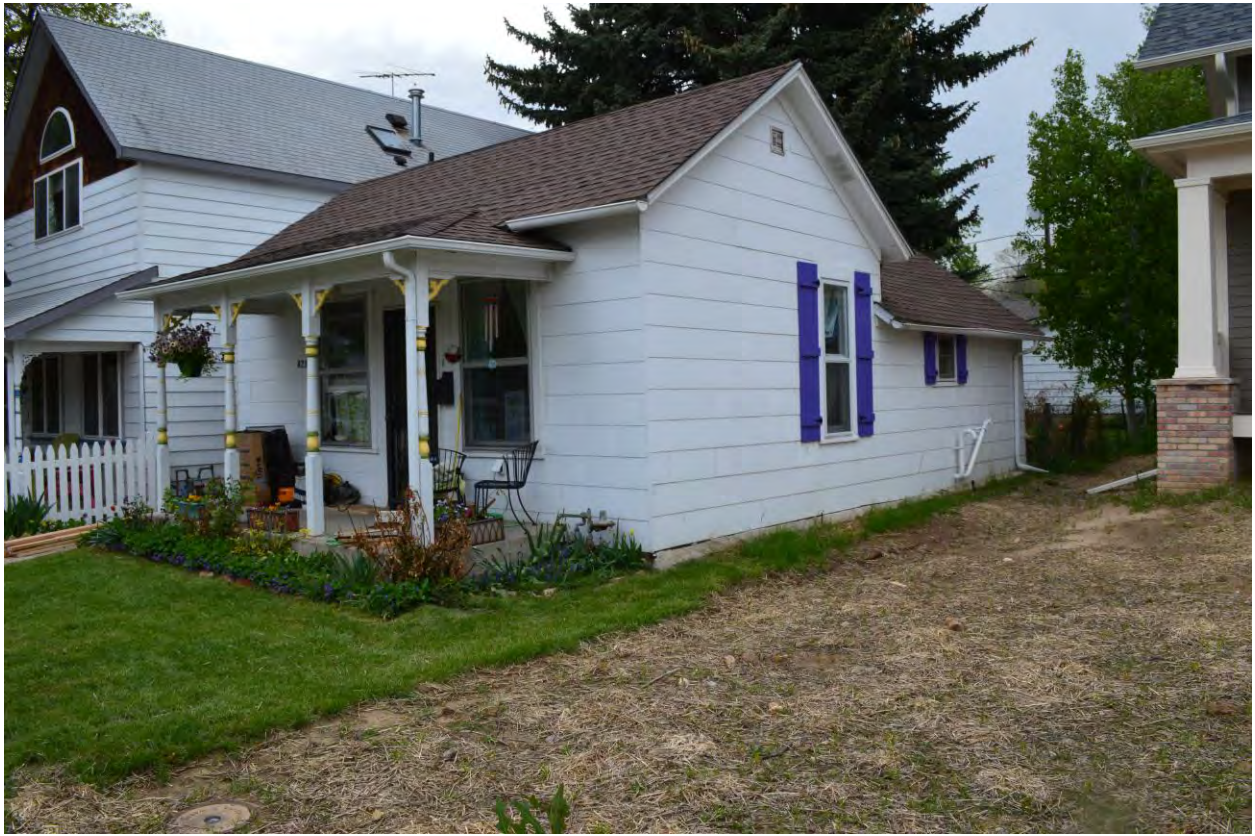
821 LaFarge Current Photo (Northeast corner)

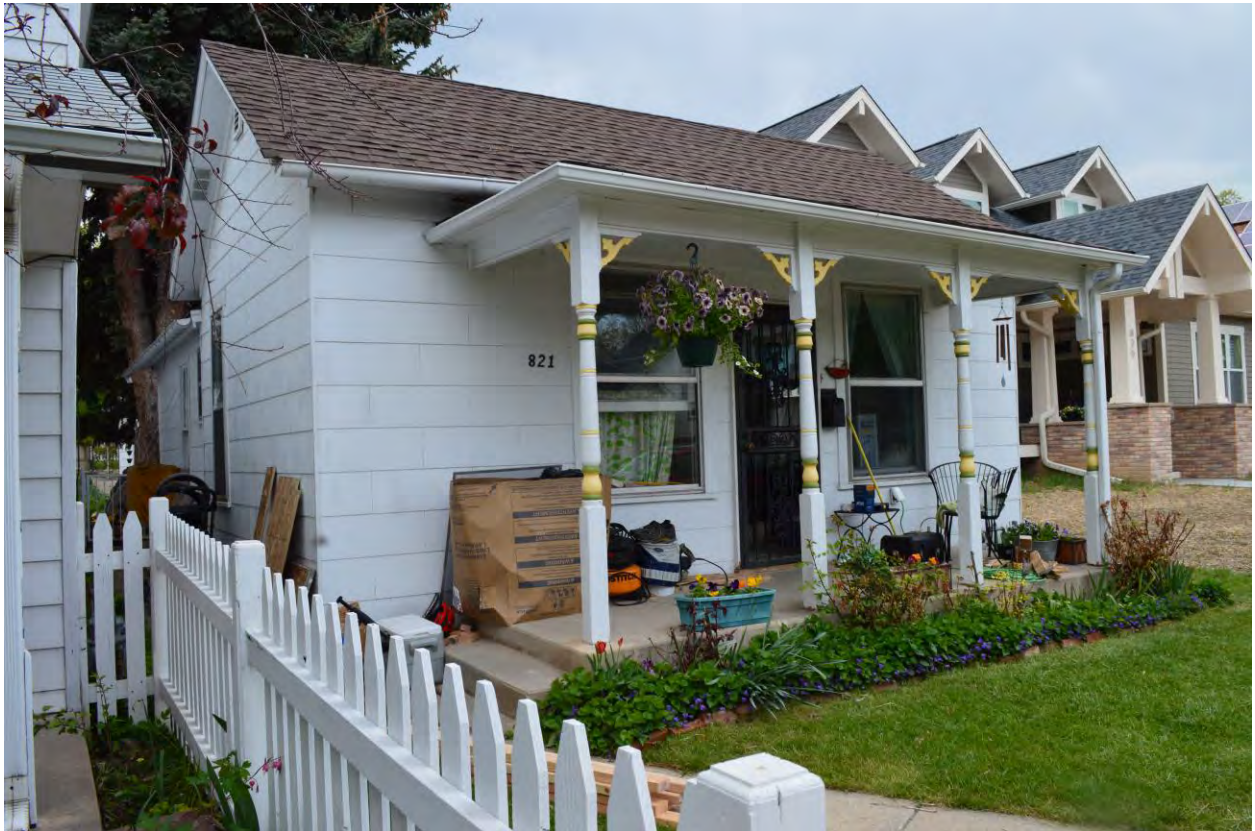
821 LaFarge Current Photo (Southeast corner)

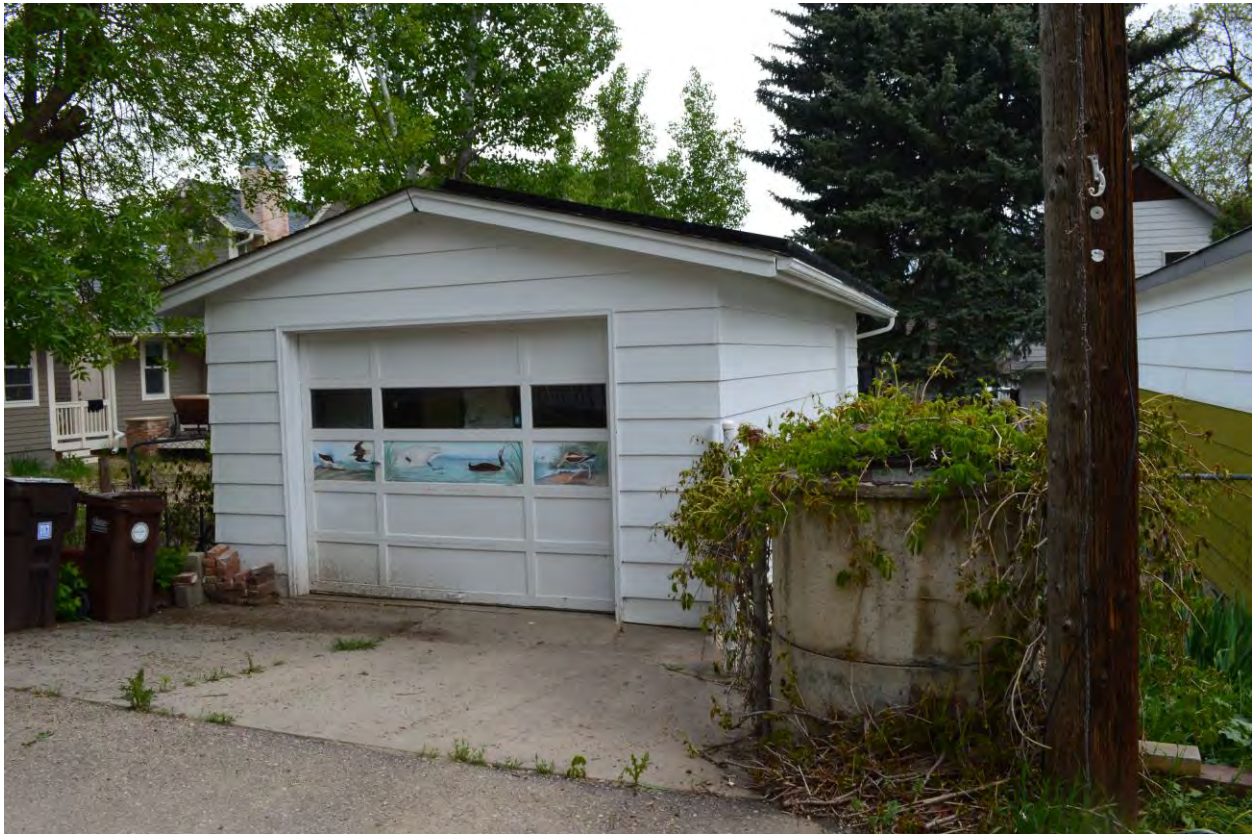
821 LaFarge-Garage Current Photo (West elevation)

A wood-frame **Garage** is located on the alley to the west of the house. This building has a concrete slab foundation and floor, painted white horizontal masonite siding, and a low-pitched gable roof, with brown asphalt shingles and boxed eaves. One single-light fixed-pane window is located on the east elevation. A painted white wood-paneled roll-away garage door opens onto the alley on the west elevation. A single, painted white wood-paneled door, opens onto a 2-step concrete stoop, at the east end of the south elevation.

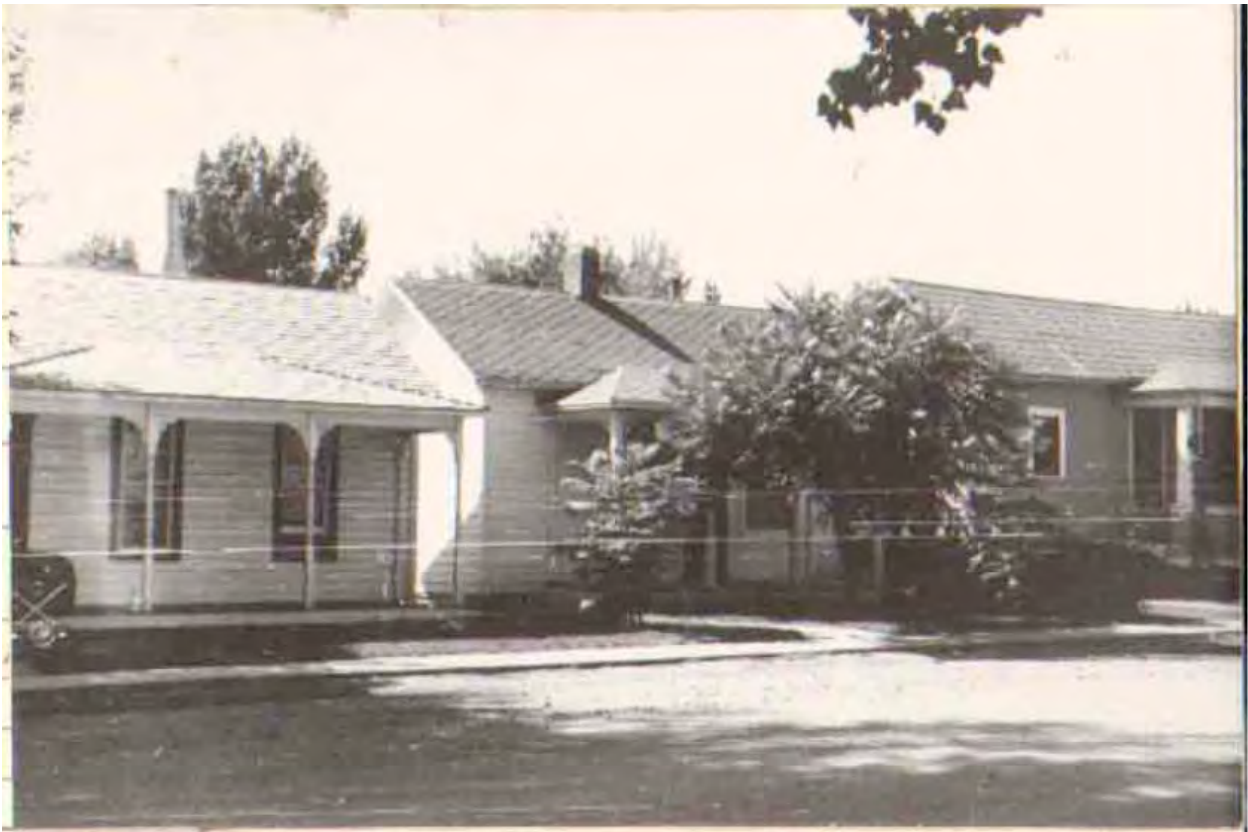
821 LaFarge Avenue (1948 Assessor's Photo)

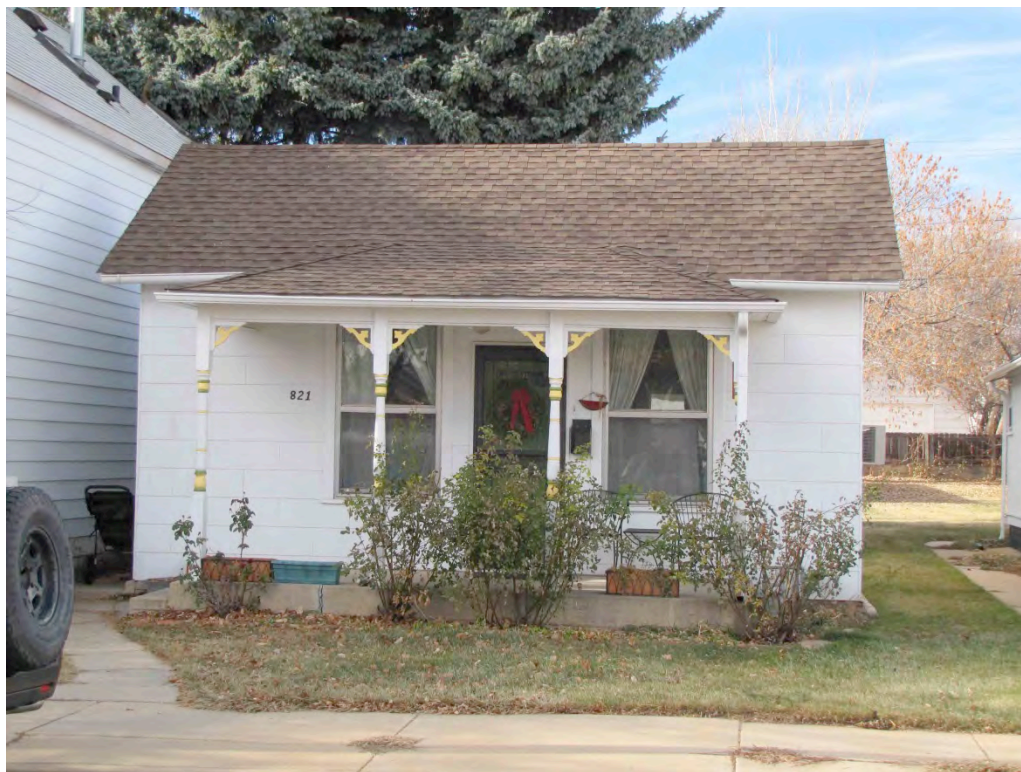
5BL7990_821LaFarge_01 east

This house is situated on a narrow lot, with a small unfenced planted grass front yard to the east, and a larger backyard, enclosed by a woven wire fence, to the west. The house is a wood-frame residence, supported by a low concrete foundation, with white asbestos shingle siding exterior walls. The house is covered by a moderately-pitched side gable roof, with asphalt shingles and boxed eaves. An early saltbox addition extends the building to the west. Windows are entirely 1/1 and 2/2 double-hung sash, with painted white wood frames and surrounds. The building's symmetrical facade is located on the east elevation, where two 1/1 double-hung sash windows flank a painted blue solid wood front door, with a wrought iron security door. The door opens onto a concrete porch which extends nearly the full length of the facade. Painted white turned columns, with scrolled brackets, support the porch roof. A painted white wood-paneled door, with a black wrought iron security door, opens onto a small concrete porch on the west elevation. The porch is covered by a shed roof with painted white 4" by 4" wood post supports.

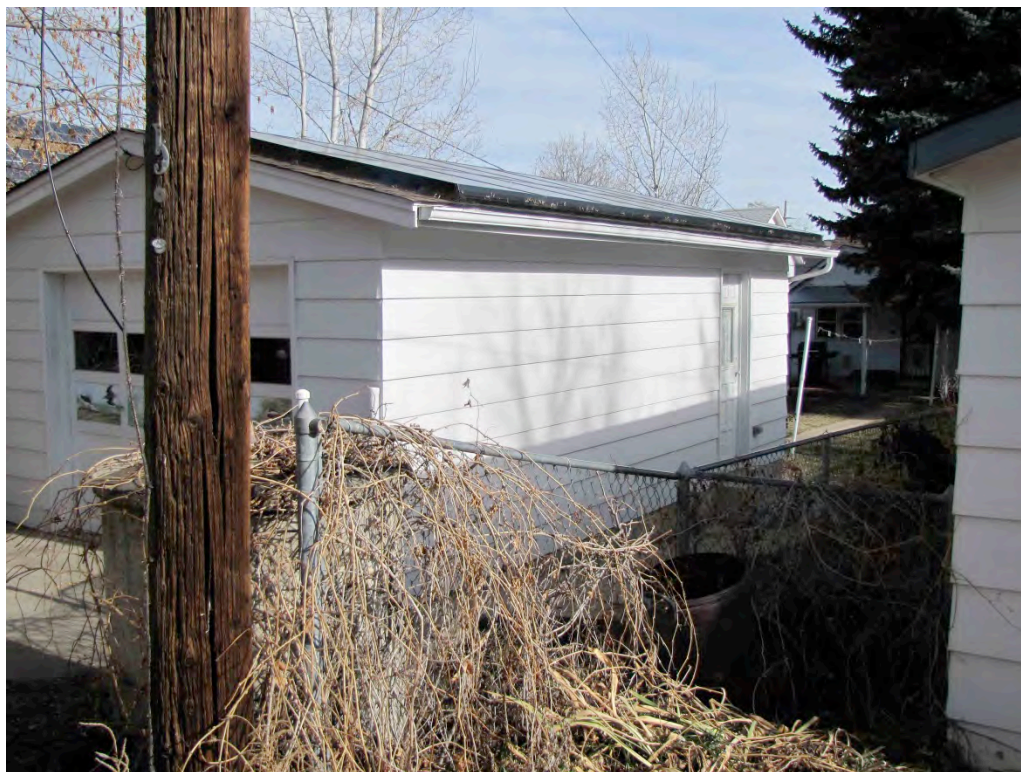
5BL7990_821LaFarge_05 garage southwest

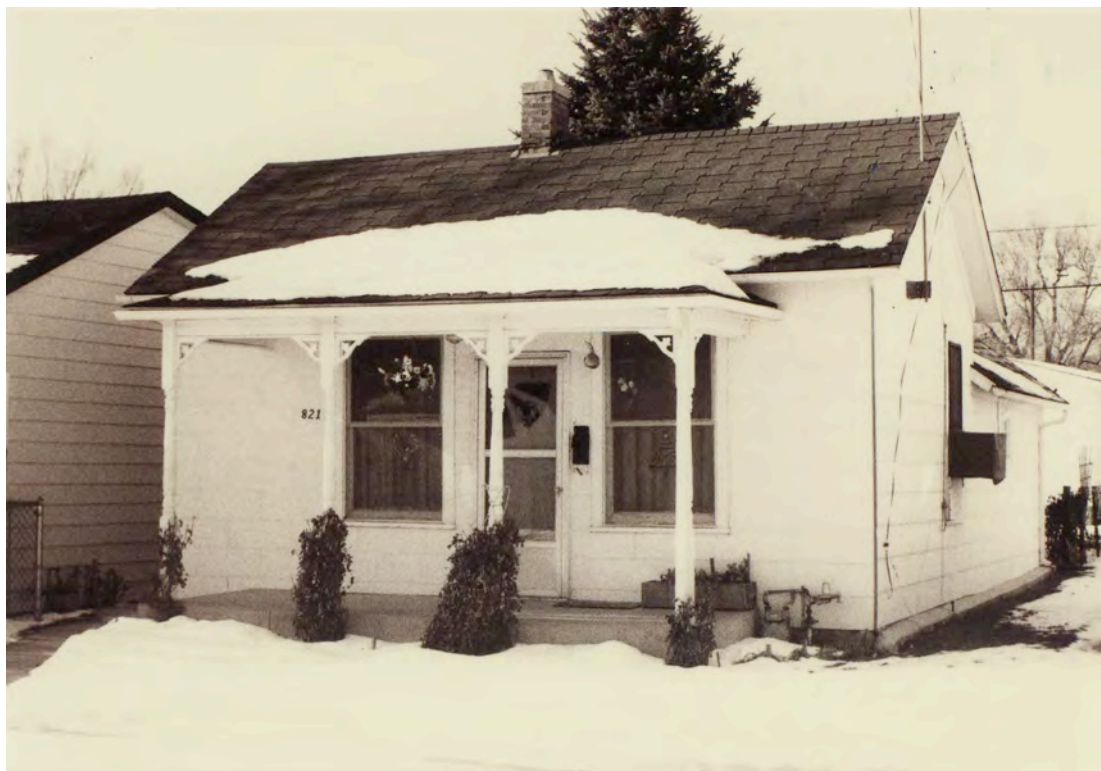
821 La Farge ca 1960's-1970's. Louisville Historical Museum, 2008.008.058.

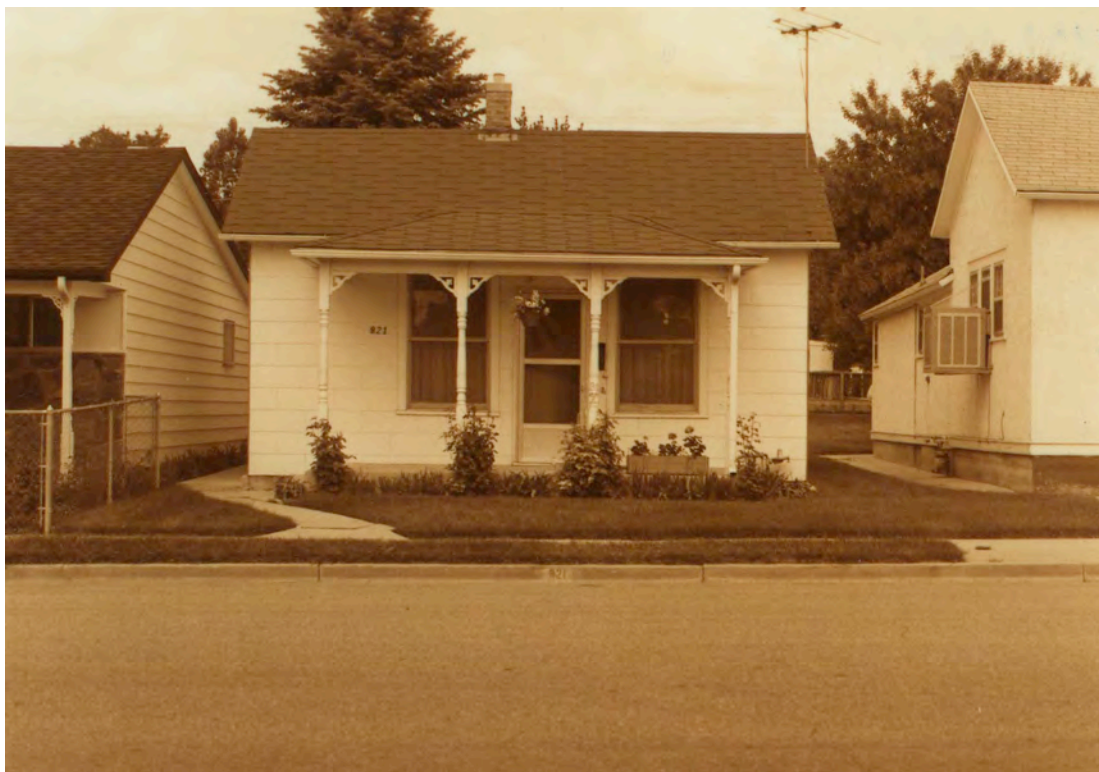
821 La Farge ca 1960's. Louisville Historical Museum, 2008.008.059.

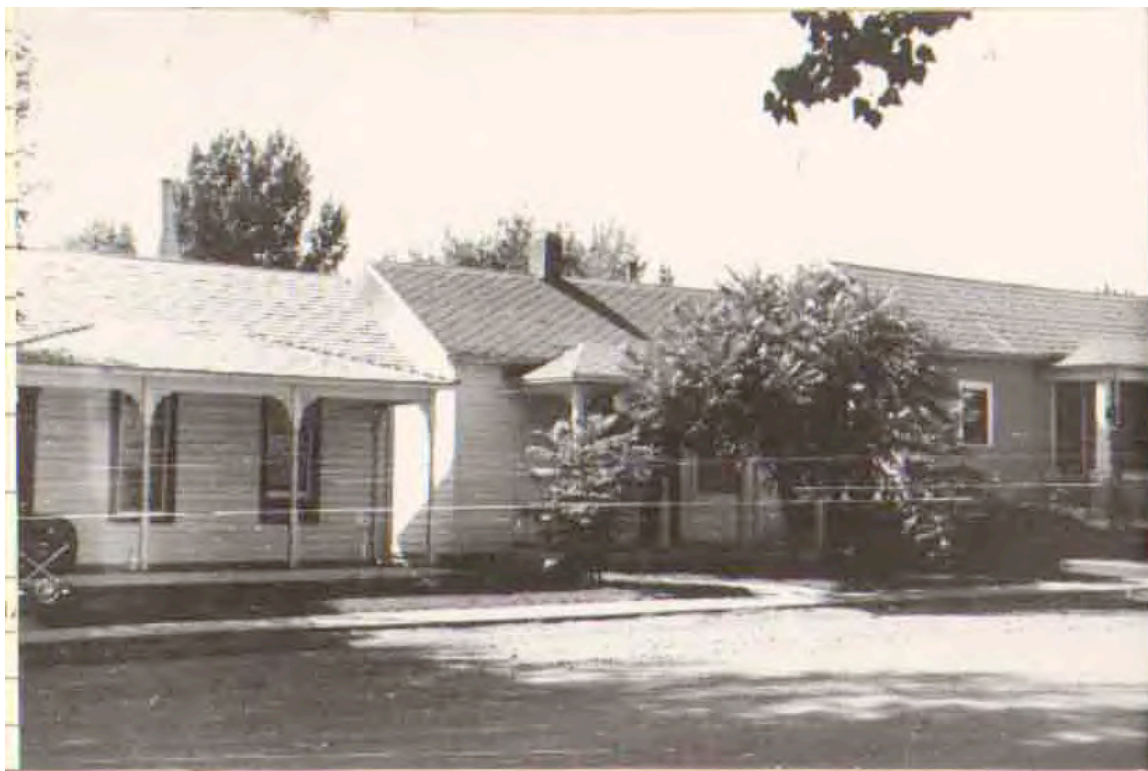
821 La Farge. Boulder county Real Estate Appraisal card, 1948.

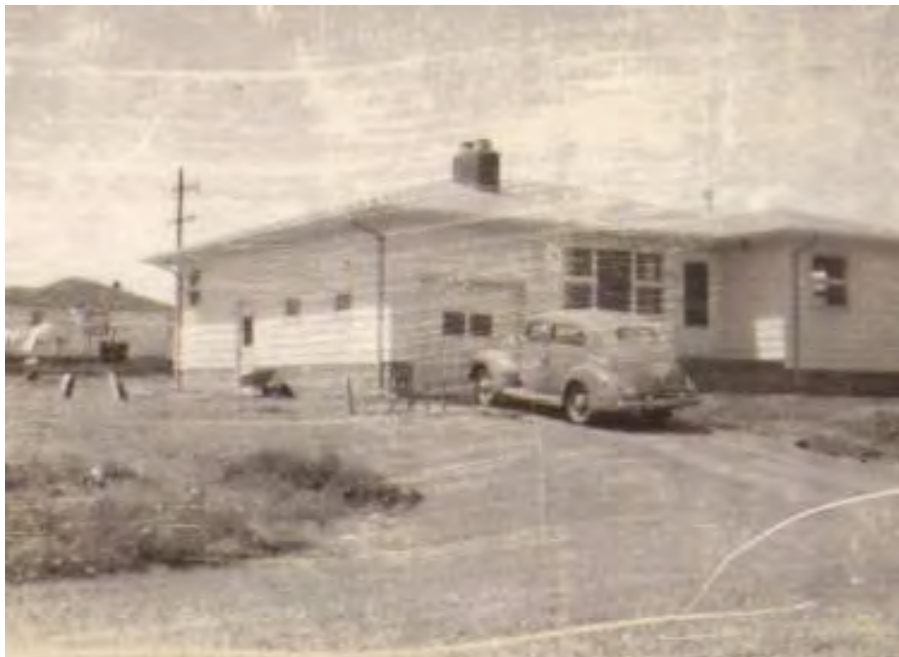
1309 Lincoln - 1955 Assessors' Photo

The structure is clad in what appears to be vinyl siding. There is also vinyl siding underneath the wide, overhanging eaves. Although they have been painted since the 1955 photo, the windows and window openings appear to be original. The garage door also appears original. It is likely that the front door has been replaced. The low retaining wall and wall along front stair have been added since 1955. The structure has retained the original brick central chimney. There is a small covered patio on the rear of the property.

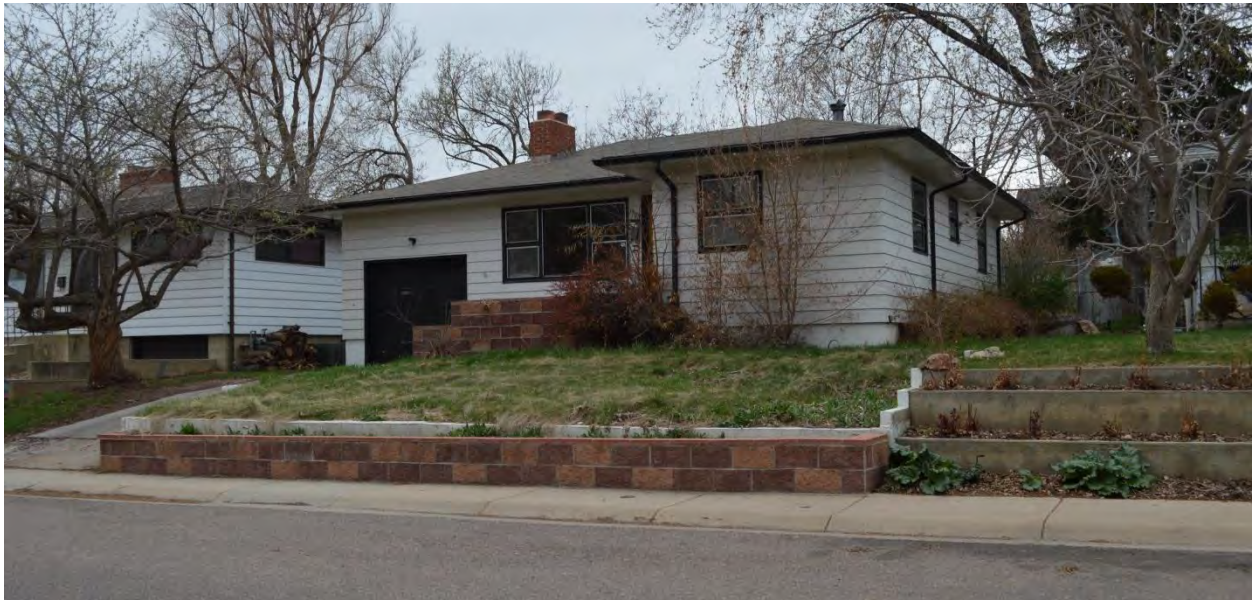
1309 Jefferson Detail – Current Photo

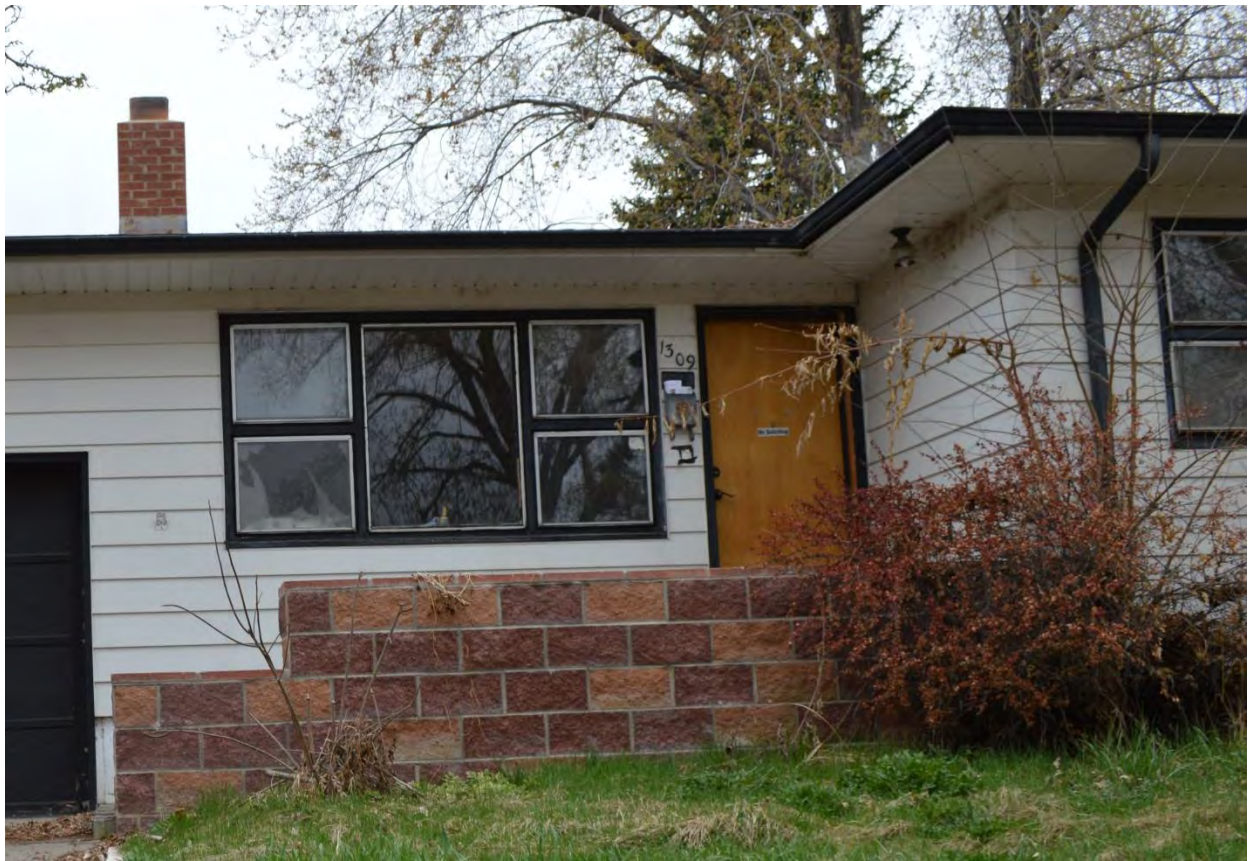
1309 Jefferson West Elevation – Current Photo

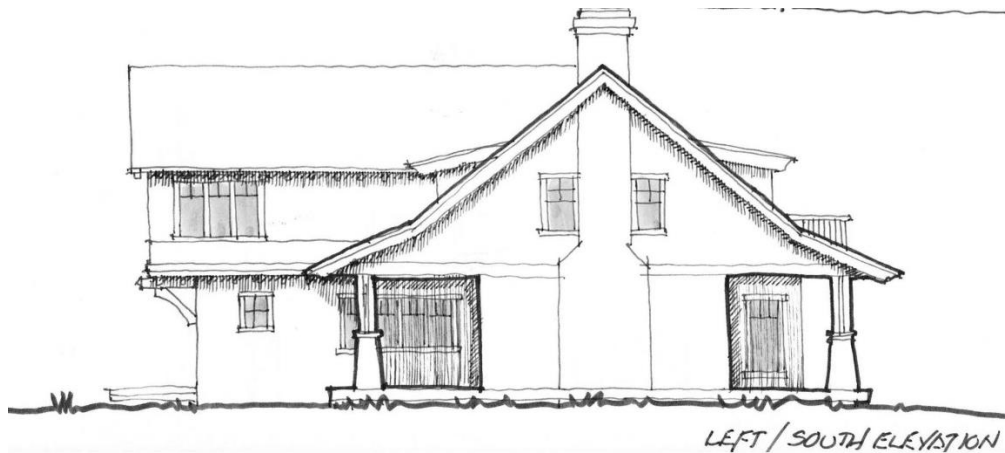
The applicant has submitted conceptual drawings for the proposed new structure.

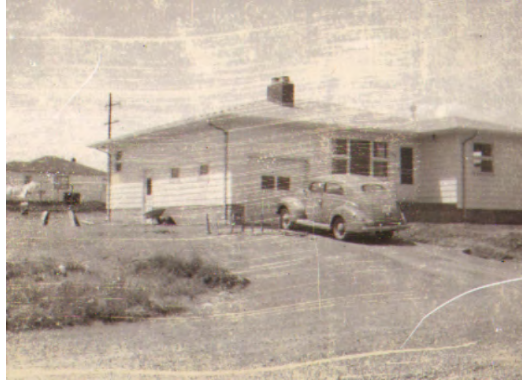
The following photo of the house and a ground layout sketch are from the Boulder County Assessor card that dates from 1955, not long after the house was built. (The address stated on the card is 1306 Jefferson, but the legal description, the photo, and the stated owners make it clear that it is the card for 1309 Jefferson.)

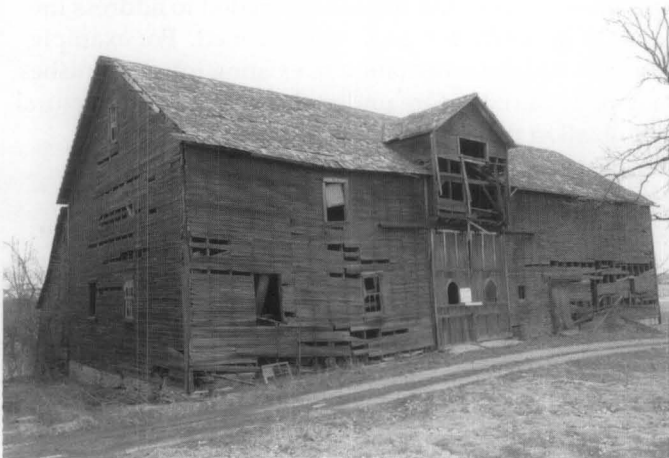
Figure 4. For small or simple projects, the project team may include only one or two specialists while complex projects may involve a large number of investigators and specialists. For example, evaluation of this barn may primarily involve a historian, an architectural conservator, and a structural engineer. Photo: Wiss, Janney, Elstner Associates, Inc.

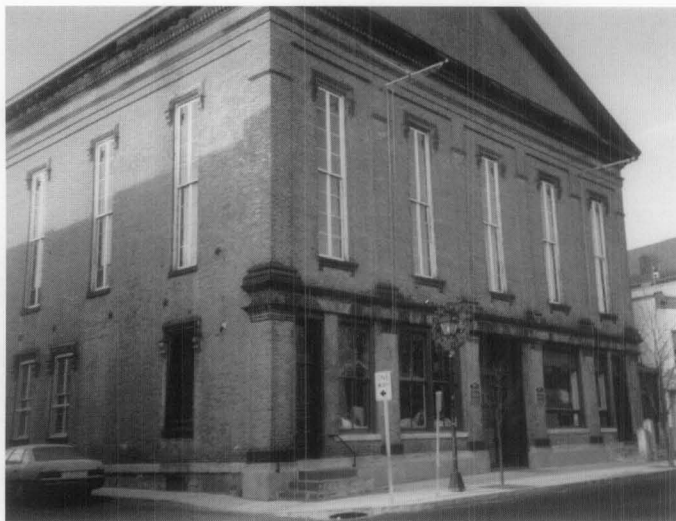
Figure 5. At the Hudson Opera House, a multi-arts center in Hudson, New York, the historic structure report was prepared incrementally. The first phase of the report focused on assessment and recommendations for repair of the roofing, the most critical issue in preservation of the building. Photo: Gary Schiro.

Incremental preparation. If budgetary constraints preclude completing the historic structure report as one project, it can be prepared incrementally (Fig. 5). The work recommendations should not be developed or implemented prior to completion of research and investigation, except for emergency stabilization to prevent immediate failure or damage, or temporary measures to address critical health and safety issues. A partial historic structure report can be completed in preparation for anticipated work that must be initiated to preserve or protect the building. This type of report includes analysis of only those building elements and systems that may be affected by the proposed work, and involves only the specialists needed to address the types of investigation and work planned. For example, research and documentation of existing interior finishes may be required before undertaking localized structural stabilization that will require removal of interior materials.

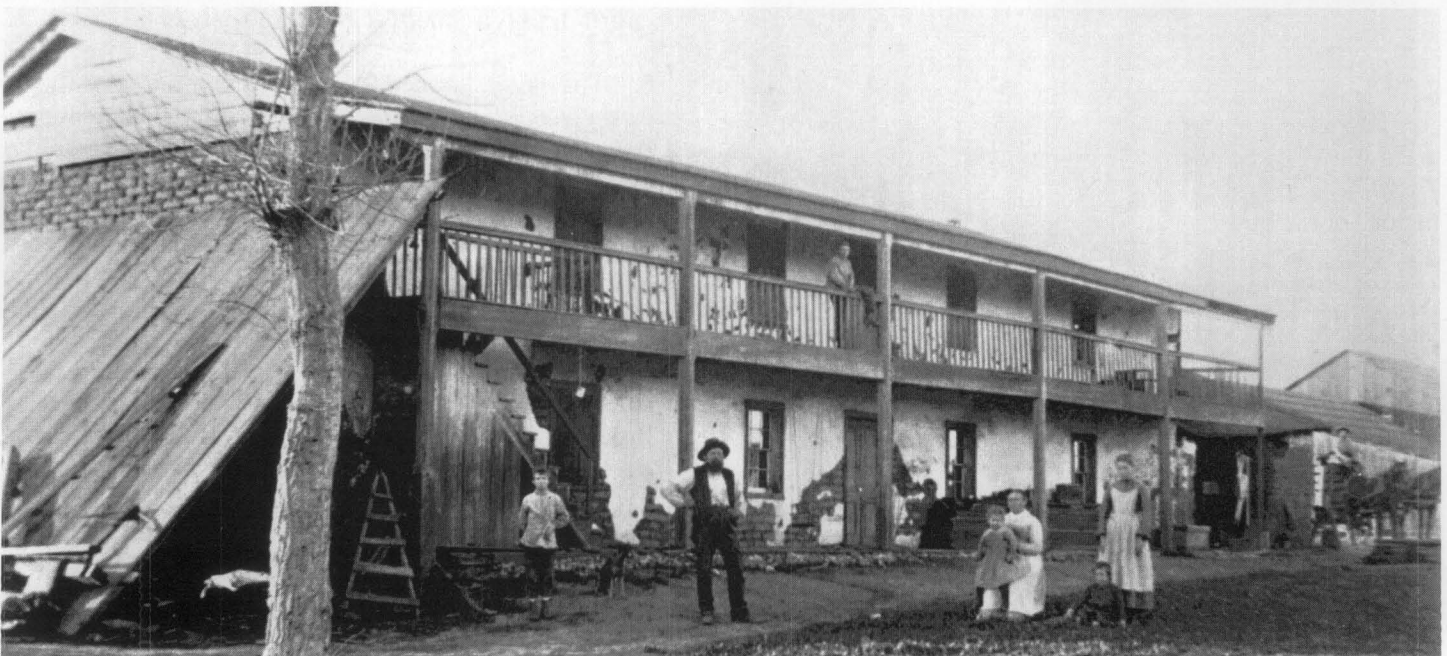
Figure 6. Historical photographs are an invaluable aid and time saver in establishing a building's original construction and evolution; in guiding the replication of missing features; and even in understanding existing material deterioration. The availability of information, such as archival photographs, surviving original architectural drawings, or HABS documentation, has a direct bearing on the cost of preparing a historic structure report. In this circa 1890 photo of the Rancho San Andrés Castro Adobe, the "lumbering up" on the south end is a character-defining feature of adobe construction, rarely seen today. Photo: Historic photograph from the Historic Structure Report for Rancho San Andrés Adobe by Edna Kimbro, State Historian, California State Parks, Monterey District.

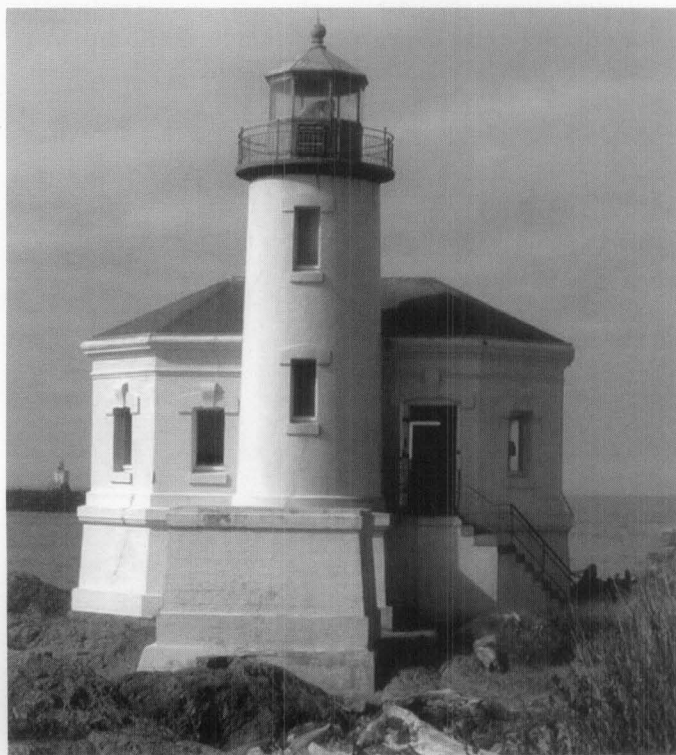
Figure 7. Numerous factors influence the cost of preparing a historic structure report including the level of significance, size, and complexity of the property; required treatment and use; existing condition; and the location and access to the structure. Historic structure reports were prepared for several small lighthouses along the Oregon coast, including the Coquille River Lighthouse, shown here. Photo: Wiss, Janney, Elstner Associates, Inc.

4. The *location of and access to a historic building* is a cost factor for some studies. A property in a remote mountain location can involve high travel costs relative to properties in or near an urban area. A structure requiring special techniques for exterior physical inspection would involve higher access costs than a small residential structure (Fig. 7).

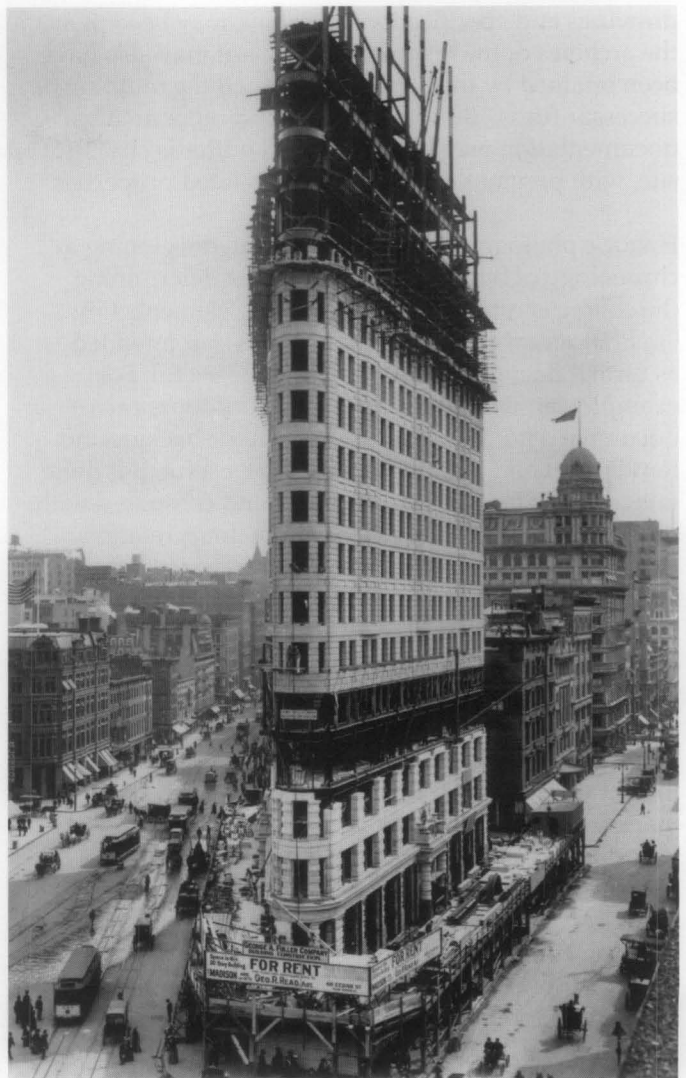
Figure 8. Historical research is directed toward gathering information on a structure's history, original construction and later modifications, occupancies, and uses over time. Research may range from national repositories such as the Library of Congress to local collections or private family records. Old newspapers, architectural journals, and even manufacturing trade catalogs can be surprising sources of historical accounts and illustrations. This circa 1902 photograph of New York's Flatiron Building is of the construction in progress; such photographs are useful in understanding building chronology as well as concealed conditions of as-built construction such as building framing. Photo: Library of Congress, LC-D401-14278. The interior photograph of the former Bemir Drug Store in Rochester, New York, showcases a rubber tile floor as illustrated in a 1925 publication by the United States Rubber Company.

Historical research. Archival research should be directed toward gathering information on the building's history, original construction and later modifications, occupancies, and uses over time (Fig. 8). Research for the report is not intended to produce a large compendium of historical and genealogical material, but rather selected information necessary to understand the evolution of the structure, its significance, and justification for the treatment selected. For significant sites where other types of studies such as archeological investigations or a cultural landscape report have been completed or are underway, coordination is required to ensure that research information is shared and that the research effort is not duplicated.

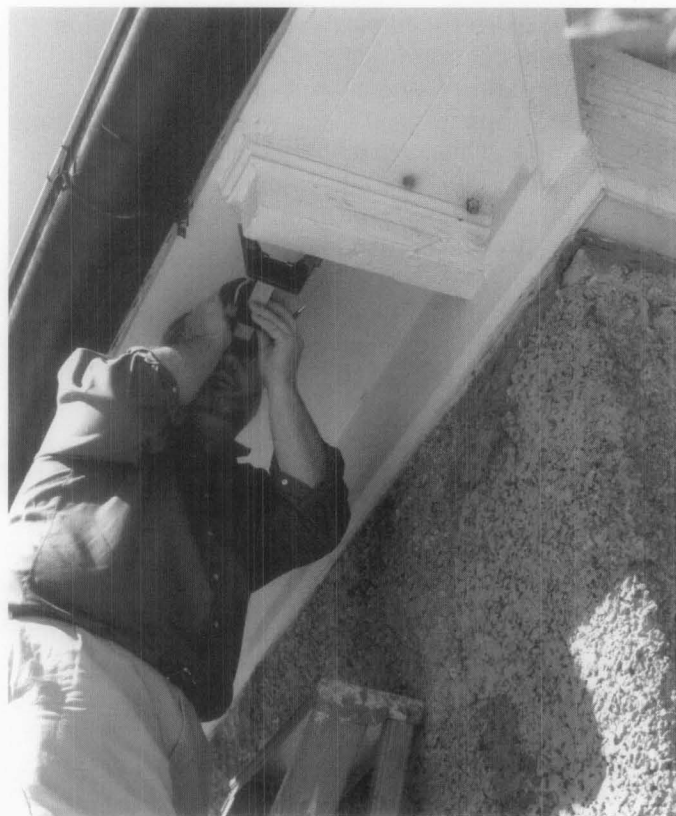
Figure 13. Paint studies may not only help establish the chronology of paints and paint colors used on a building but also may aid in the dating of existing architectural features. Examination of the paint layers on these modillions utilizing a hand-held microscope enabled an investigating team to confirm in the field which modillions were original and which were later replacements. Photo: Charles Fisher, National Park Service.

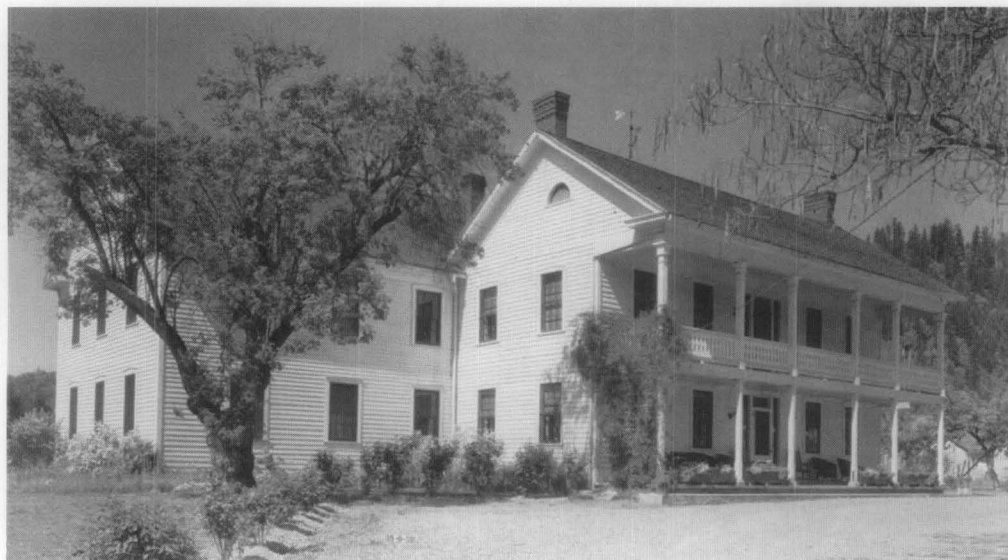
Figure 14. The treatment approach selected for a building usually is determined by the intended use of a property, funding prospects, and the findings of an investigation. The Wolf Creek Inn, operated by the Oregon Parks and Recreation Department, is among the most intact and oldest active travelers' inns in Oregon. The historic structure report outlined a rehabilitation treatment which included such work recommendations as repairs to specific historic fabric, landscape restoration and site improvements, and upgrading of the building's mechanical and electrical systems. Photo: Historic American Building Survey, 1934.

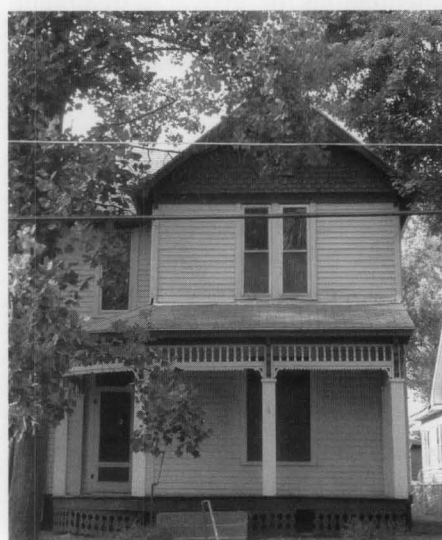
Figure 16. The historic structure report for the Noland House in Independence, Missouri, a vernacular house that is significant as part of the context of Harry S Truman's life and family in Independence, Missouri, includes photographs and measured drawings to record existing features and conditions of the building. The measured drawings will also provide a basis for construction documents for future preservation work. This photograph and drawing illustrate the front elevation of the house. Photo and drawing: Bahr Vermeer Haecker Architects.

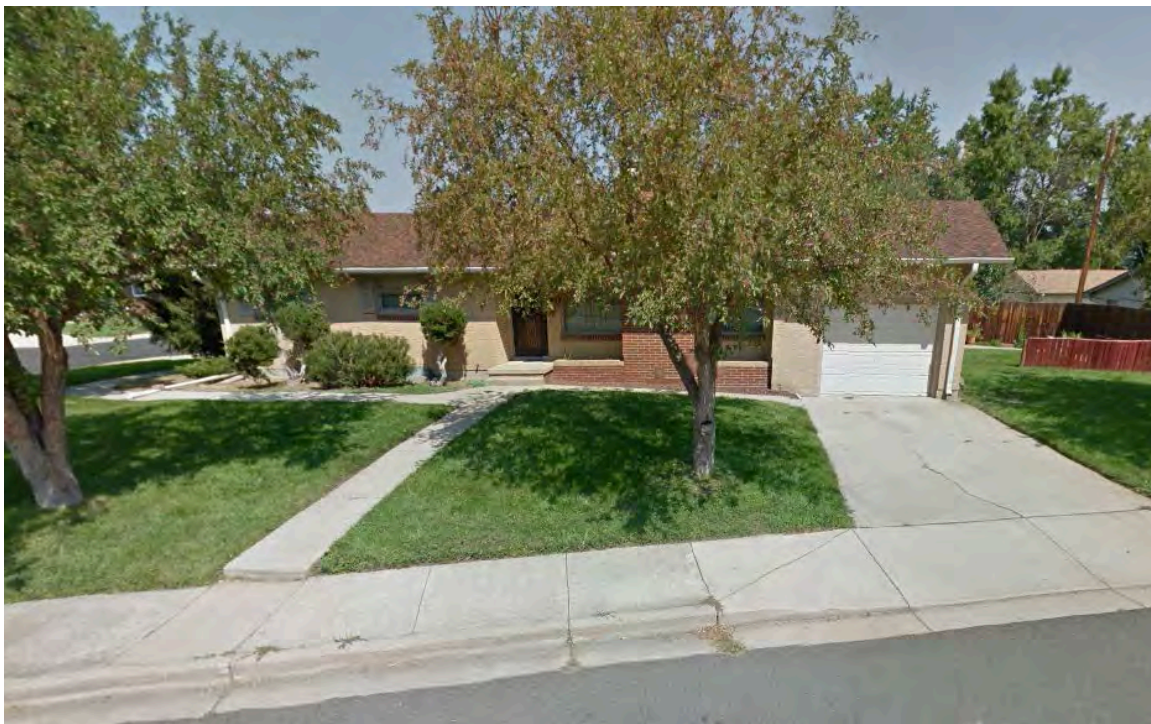
116 Aline Street

On April 23, 2015 Planning Staff and two subcommittee members of the HPC reviewed a request to replace the windows at 116 Aline Street.

After deliberation, the HPC subcommittee decided to release because the window replacement is like-for-like and will have minimal impact on the integrity of the structure.

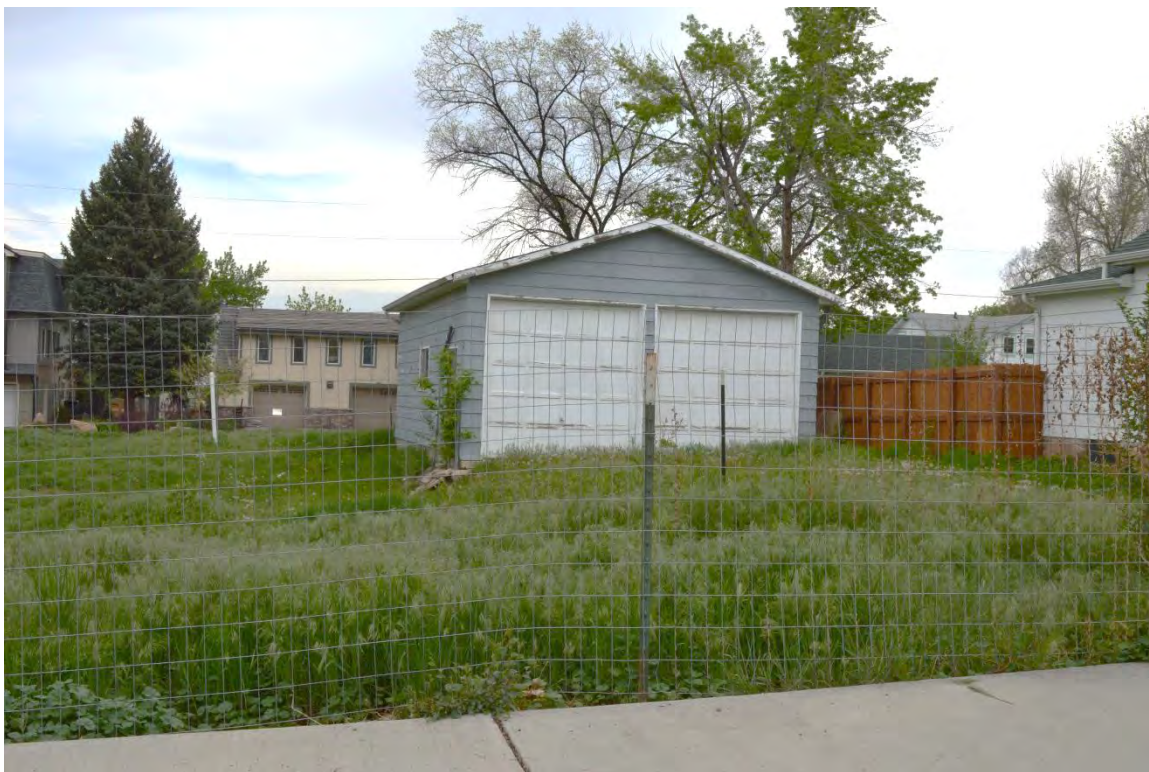
536 Main Street - Garage

On May 8, 2015 Planning Staff and two subcommittee members of the HPC reviewed a request to demolish the garage at 536 Main Street.

After deliberation, the HPC subcommittee decided to release the permit because the associated home was demolished in 2005. There is insufficient evidence for architectural and social significance of the remaining garage.

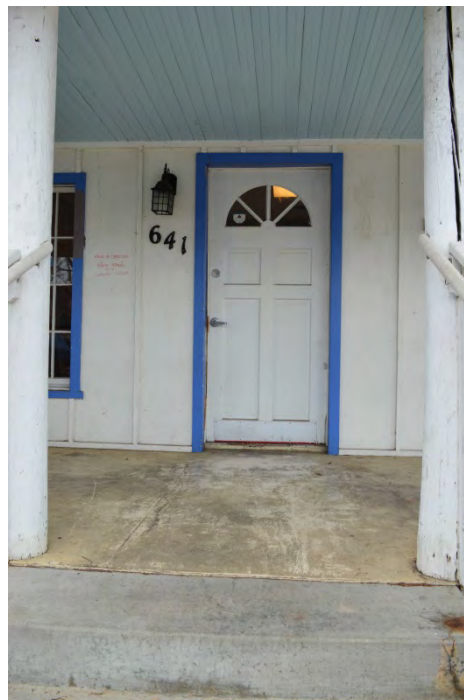
641 Main Street - Door

On May 7, 2015 Planning Staff and two subcommittee members of the HPC reviewed a request to add a rear addition, replace the front door, and add signage to 641 Main Street.

After deliberation, the HPC subcommittee decided to release the permit because the project has been designed so the addition would have minimal impact on the existing historic structure. Also, the existing door is not historic.
